FLINDERS ISLET YACHT RACE INQUIRY

Cruising Yacht Club of Australia Internal Inquiry

Oxenbould, Kellett and Brooks

January 2010

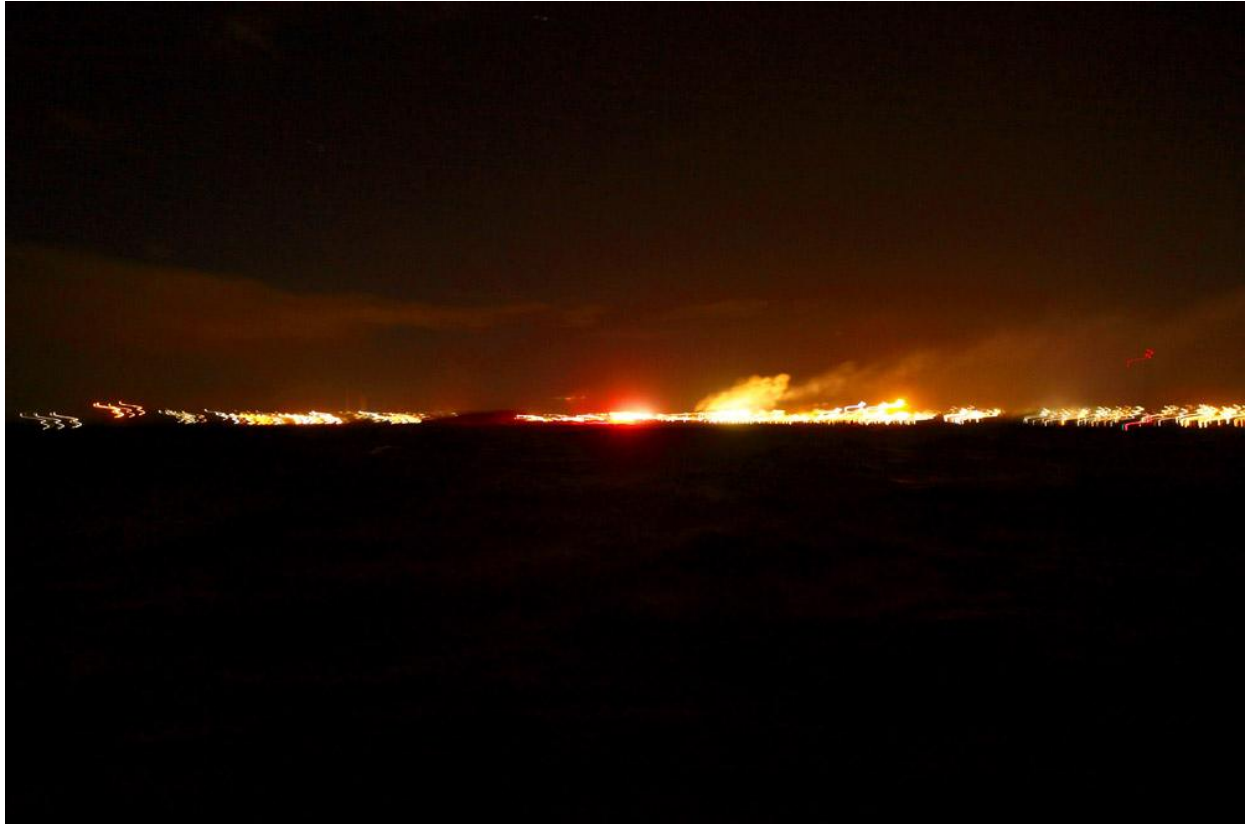
The Port Kembla shoreline and Flinders Islet viewed from the north east – Islet to left of centre on horizon – Bright light in centre last residue of a flare – smoke to the right from flare
(Photograph Courtesy of Christophe Launay – *Living Doll*)

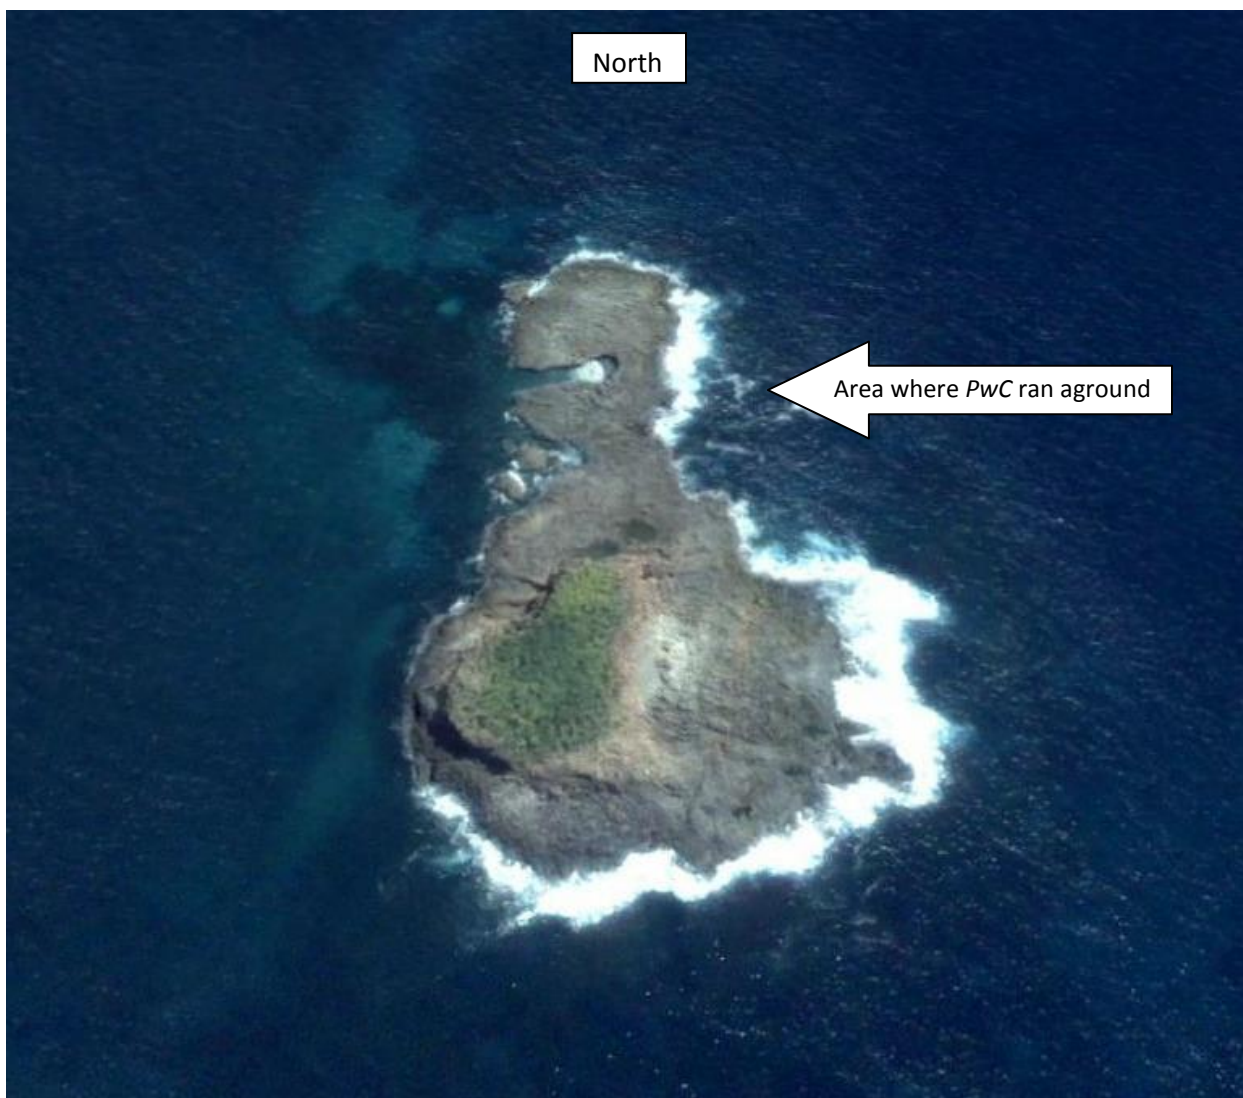
Flinders Islet

53. The boat was now on a north north westerly heading and from the mast it appeared that it might just miss the islet. At about 2.35am on Saturday 10 October 2009, *PwC* ran aground about 30 metres or a boat length from the edge of the visible rocks. The boat stopped dead like a car crash. People were thrown about on deck and gear was thrown about below decks. Matt Pearce was tethered to the port jackstay and ended up at the forestay from the mast. The boat was upright, pointing north west and all crew were onboard. The bow ended up about 10 metres from the visible rocks.

54. The sheets were dumped to depower the sails and prevent the boat driving further on to the rocks. Almost immediately the boat was subjected to sets of waves breaking on to it. The sea and swell were coming from the south and there appeared to be a bombora working off the eastern extremity of the islet that was increasing the size of the waves and they were bending around towards the west to break on the shore.

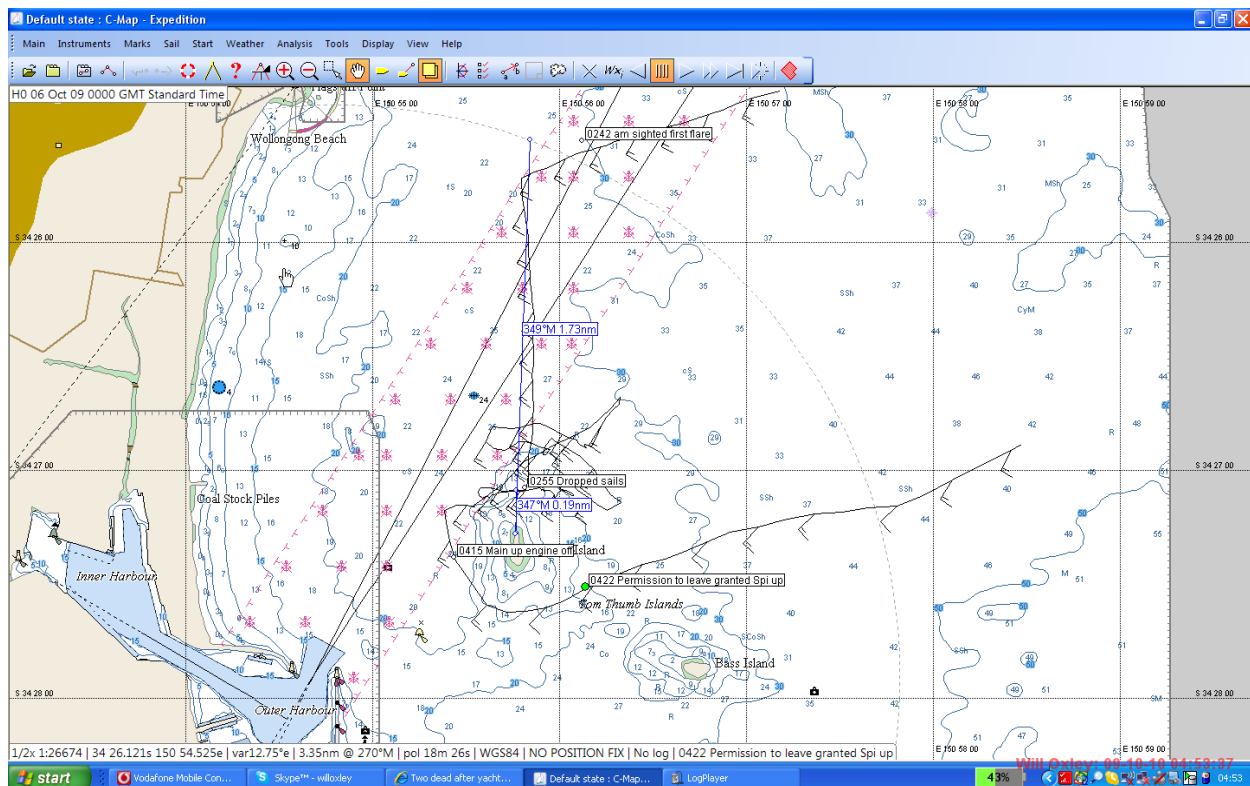
Track chart from *Yendys* – approaching Flinders Islet and SAR

77. The four boats sailed a similar track in their approach to Flinders Islet. All boats closed the coast on port tack about 1 to 2 miles north of the islet and planned to tack on to starboard when they could lay the mark and pass safely to the west of the islet. This was a different approach and tactics to *PwC*. At about 2.10am, *Quest* experienced a major wind shift, an easterly slant of about 50° which provided a few minutes of sprung sheet sailing and the boat was making 13.5 to 14 knots in the prevailing conditions.

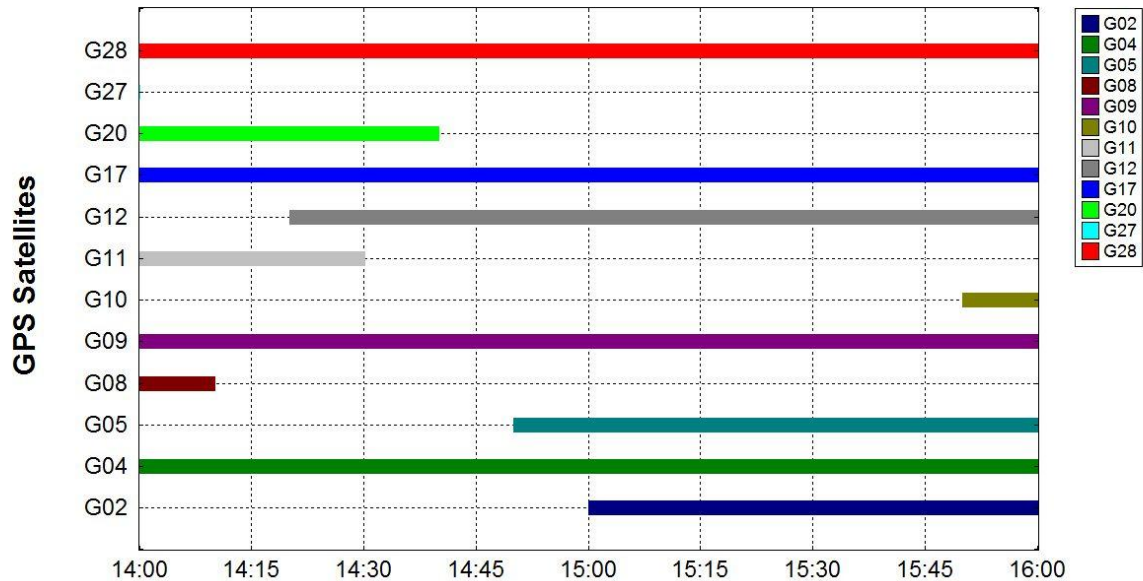
Diagram 1 – Showing the visible satellites at Flinders Island between 1400 UTC (1.00am EDST 10 Oct) and 1600 UTC (3.00am EDST 10 Oct)

111. A close examination of the sky plot (Diagram 3) indicates that 3 (G28, G17 and G12) of the 4 useable satellites were on the same bearing or within 20° of the reciprocal bearing which produces a poor quality fix. This is represented by the high DOP readings between 1.40am and 2.40am on 10 October (Diagrams 4 and 5) and it coincides with the time that PwC would have been approaching the port layline to Flinders Islet and tacked to approach the islet on port tack. At this critical stage navigation solely reliant on GPS and a chart plotter would have been degraded.

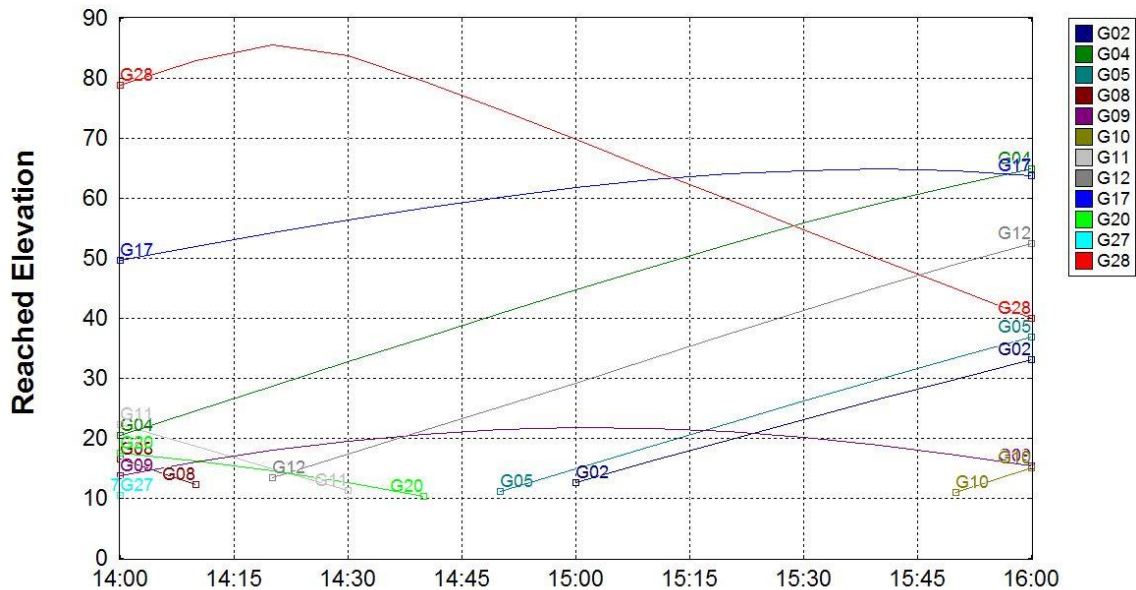
Diagram 2 – Showing the elevation of the satellites visible at Flinders Islet between 1400 UTC (1.00am EDST 10 Oct) and 1600 UTC (3.00am EDST 10 Oct)

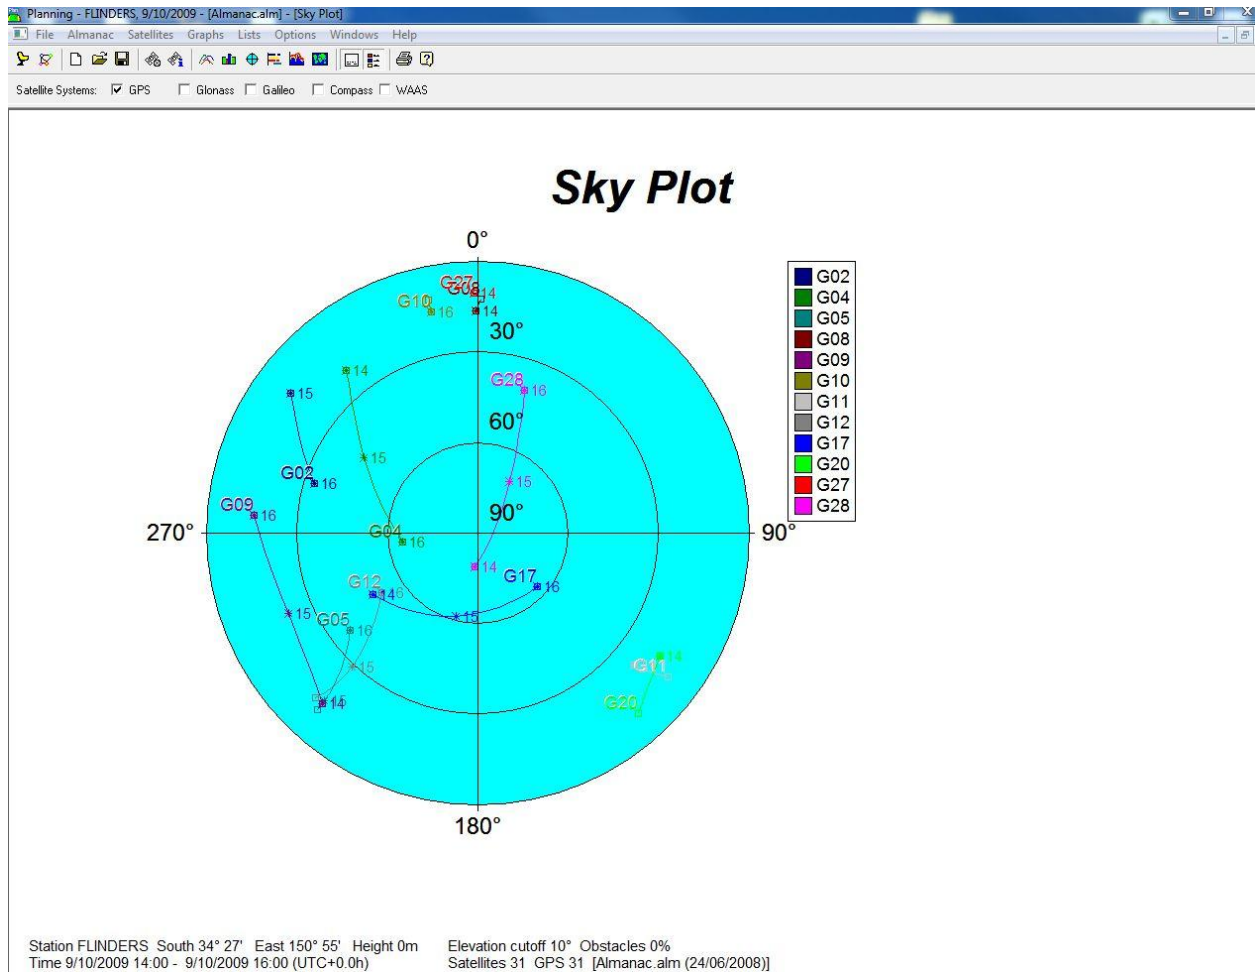
Diagram 3 – Skyplot for Flinders Islet 9/10 October – Between 1400 UTC (1.00am 10 Oct EDST) and 1600 UTC (3.00am 10 Oct SDST)

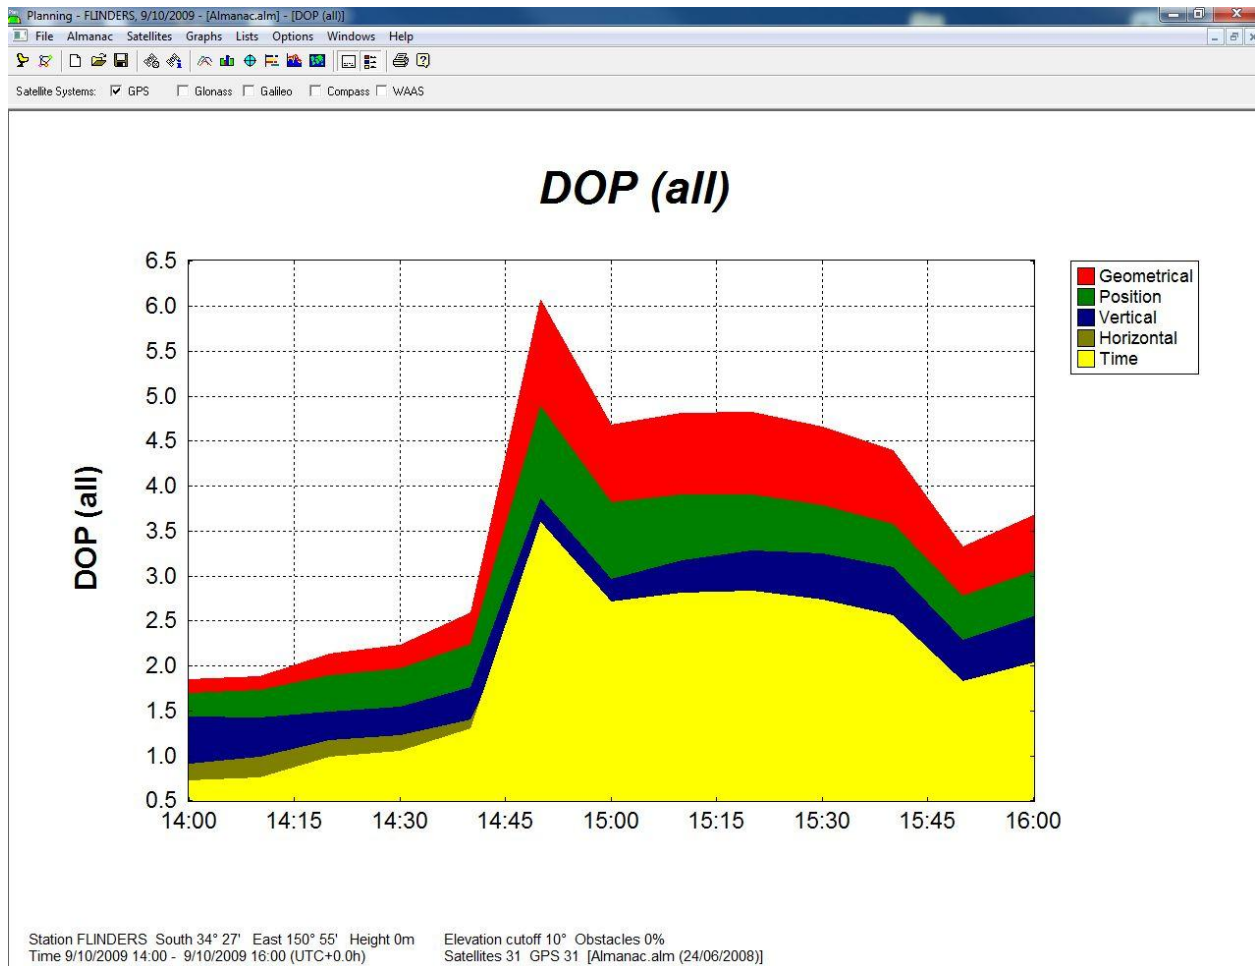
Diagram 4 – DOP Graph for Flinders Islet 9/10 October – Showing large reading (inaccuracy) from shortly before 1440 UTC (1.40am 10 October) to after 1600 UTC (3.00am 10 October)

116. Cumulatively these errors could have exceeded 100 metres or more and have misrepresented the true position of *PwC* relative to Flinders Islet. There is a reasonable probability that this occurred. The navigator of *Yendys*, Will Oxley, also reported a problem with his GPS system and losing differential GPS causing him to change to a less accurate alternative autonomous positioning system. Subsequent conversations with Will suggest this may have been associated with a system problem onboard *Yendys* and the positioning of an aerial.

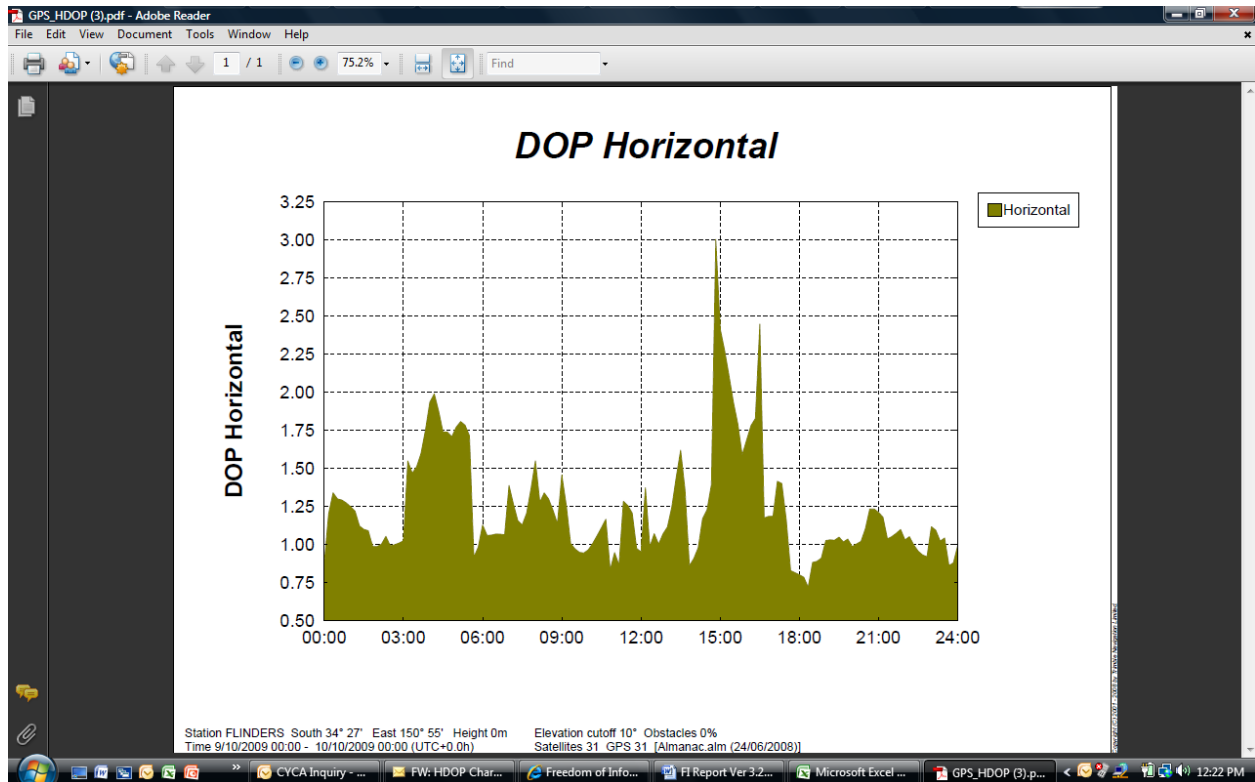
114. Horizontal DOP provides an indication of the horizontal error of the fix and is most important in marine navigation. The graph of the Horizontal DOP (Diagram 5) shows the abnormality of the readings at the critical time *PwC* approached the islet. The maximum reading of 3 is more than double the normal reading for the day.

Diagram 5 – HDOP Graph for Flinders Islet 9/10 October – Showing large reading (inaccuracy) from shortly before 1500 UTC (2.00am 10 October) to after 1630 UTC (3.30am 10 October) and its abnormality for that day
